INCIDENT DURING A DRILL EMPLOYING THE EMERGENCY DESCENT SYSTEM

QSE alert

Associated non-conformity code: NC2016003489

Wind Farm maintained by Acciona Energía, June 2016

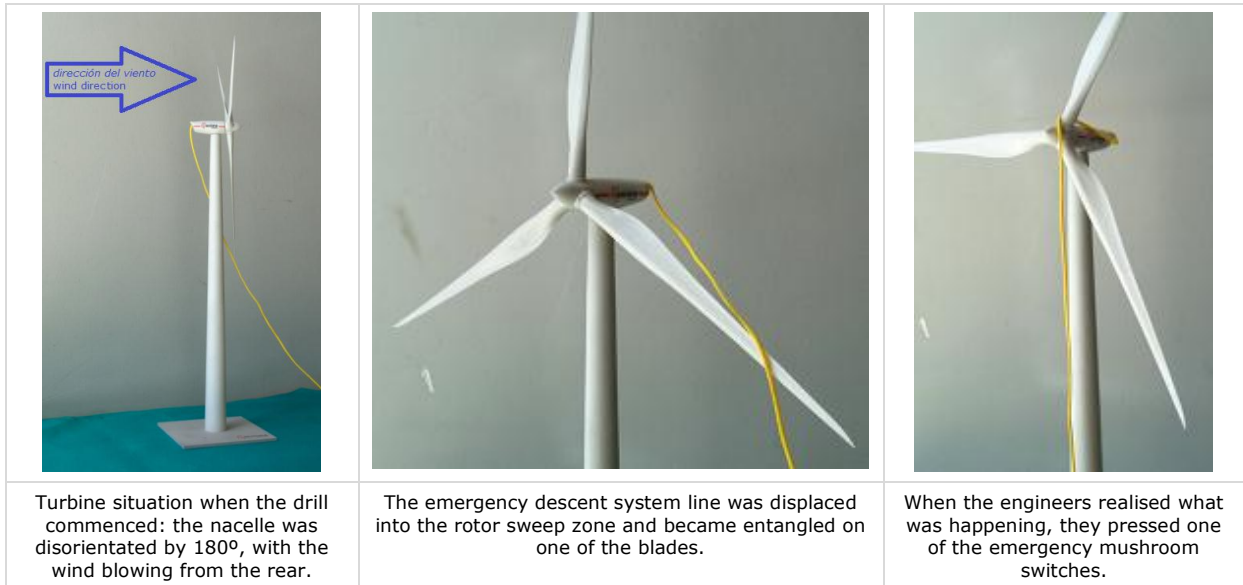
Description: the drill proceeded correctly and the engineers showed that they knew the procedures, how to correctly assemble the descent equipment and that all the required components were available. However with the descent line still deployed and while the drill supervisors comment with the technicians about the drill strong points and draw conclusions about what could be improved, the descent equipment line becomes entangled with the freely rotating rotor and becomes tangled with the hub as shown below in the graphic details.

The nacelle was disorientated by 180°, so everything pointed towards the free descent equipment line hanging outside being horizontally displaced by the wind (approximately 12 m/s) until it entered the rotor sweep zone and became entangled on one of the blades. Fortunately, the technicians quickly realised what was happening and stopped the rotor and were able to subsequently free the line from the hub without any difficulty.

This incident has shown that since the descent system line is not counter-weighted, it can be displaced horizontally by the wind during deployment and may become entangled with nearby moving and fixed elements. Which is why the following precautions must be taken into account:

- Before deploying the emergency descent system, **the rotor hydraulic brake must be applied so that it cannot freely rotate** (for example, by pressing an emergency off mushroom switch).
- The descent system line length must be adjusted to the tower height; it must not be shorter, but not much longer either (the longer its length, the greater the risk of becoming entangled with any obstacles on the ground or in the air).
- All sites must be inspected to identify those with such obstacles (in addition to the rotor), which could cause an incident: electricity lines and the guy-lines on weather towers etc. Action must be taken in detected cases in order to eliminate the risks, or to define special precautions to take into consideration to prevent incidents.
