ELECTRIC ARC IN G47 GROUND CABINET

QSE alert

Associated non-conformity code: NC2016002349

The accident occurred in an Acciona Energía wind farm, April 2016.

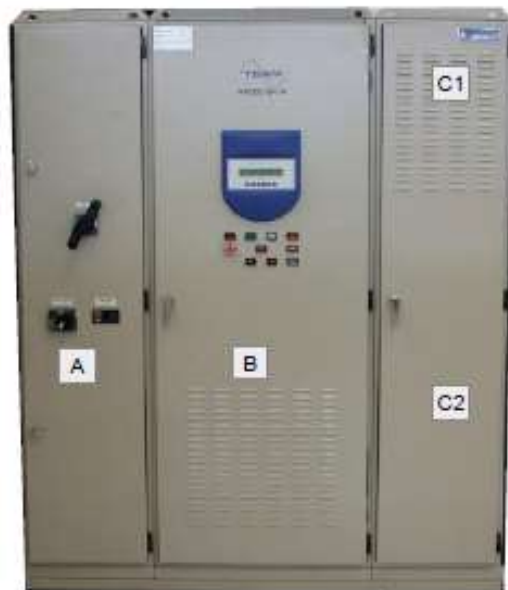
All these line components are located in Ground Cabinet compartments **“A”** and **“C”** at the base of the wind turbine:

General view of the Ground cabinet compartments (ABB)

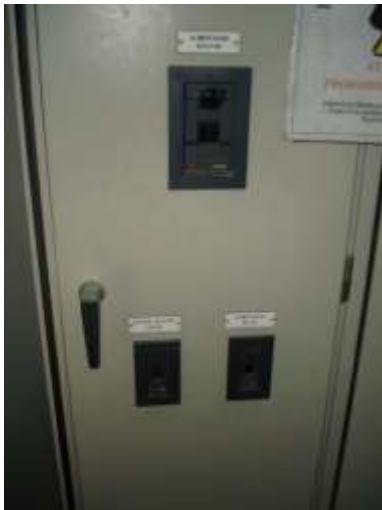
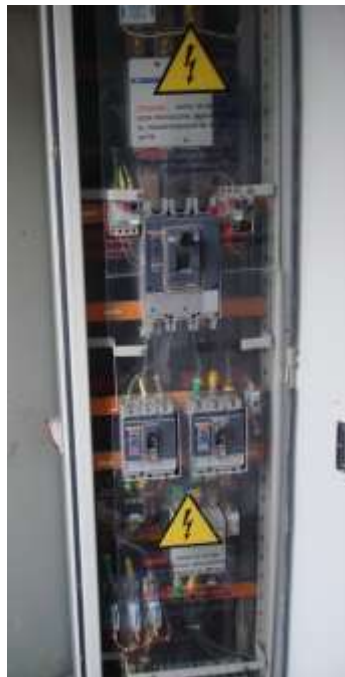
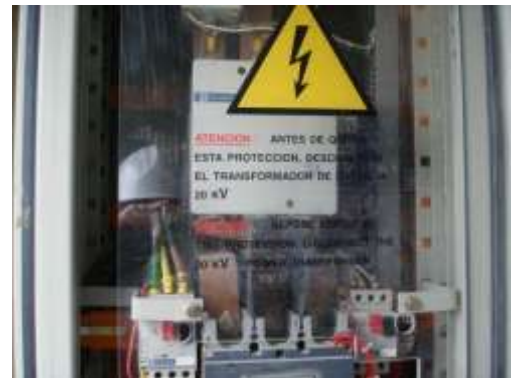
Close-up views of Ground cabinet compartment A in which the accident occurred.

Despite the warning on the methacrylate, the engineers removed this protection without de-energising the installation, stating that they required power to be applied in order to establish whether the components were "blown" or not.

During the verification of one of the over-voltage protections, "PHOENIX CONTACT" (F101), a short-circuit was caused, possibly due to simultaneous contact by one of the multimeter test leads between an auxiliary protection contact at 24 V and the corresponding phase at 690 V.

- A physical protective **barrier against** direct contact with "live" parts must never be removed **without having first de-energised the installation.**

- When performing operations, measurements, tests and verifications for electrical installations in service in which there is a direct risk of exposure to "live" parts, the use of the following PPE against electric shock risk is mandatory: **insulated gloves, suitable for the applied voltage and protective clothing against the effects of an electric arc.**

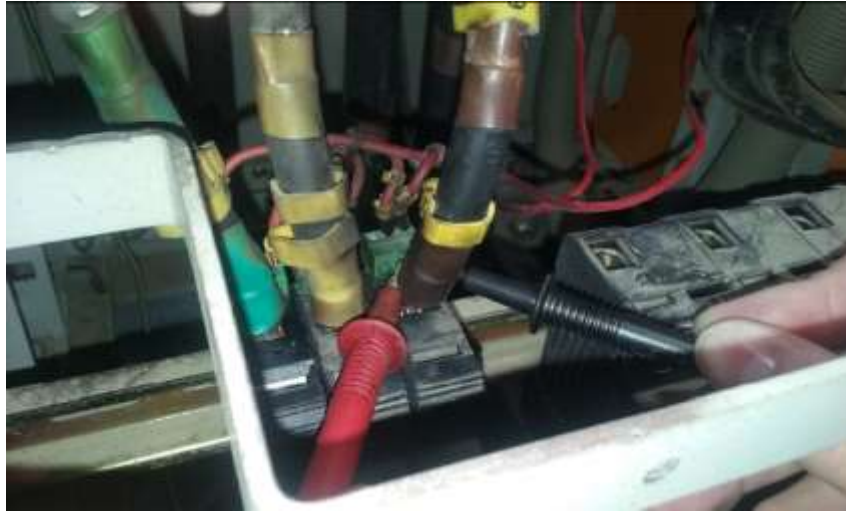
Area in which the short-circuit occurred. Simulated situation, NO POWER APPLIED

- There is necessary to **thoroughly assess the risks in each electrical cabinet** and of the tasks to be carried out in them, as applicable:
 - Improve accessibility to the components that are checked and replaced frequently so that verifications that require the removal of the methacrylate protections are reduced.

- Identify circuits that could benefit from additional protection (in this case, an isolation switch between the transformer and the machine mains input would have avoided having to disconnect the switchgear panel).

- Remove or disable any components that do not contribute to wind turbine control, but can still cause faults (eliminate unnecessary risk exposure).
 - Assess the replacement of technically obsolete components for more advanced ones, (taking into account that this turbine dates from 1995). For example, in this case, the fixed installation over-voltage protectors could be replaced by surge arresters with "base + extractable cartridge" to facilitate extraction and replacement in case of failure.
