Partial collapse of the folding door to a storage facility

QSE alert

Associated non-conformity code: NC2017000872

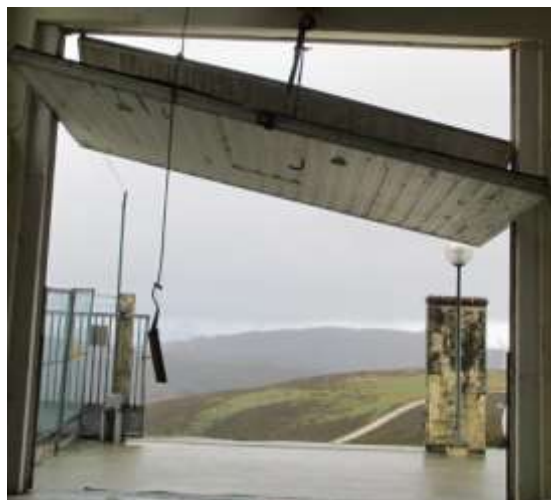
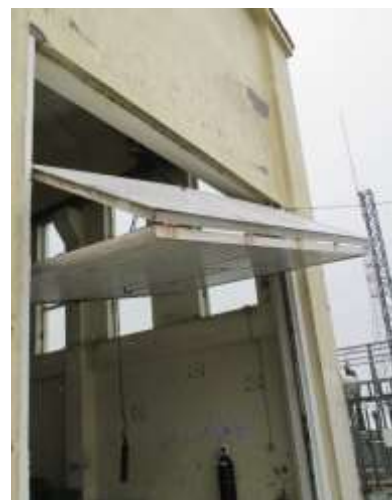
During the opening of a folding door to a storage facility, one of the securing hinges broke resulting in partial collapse of the door, but without it actually leaving the rails. No injuries were caused, or material damages.

- A periodic maintenance programme will be established for folding doors that contemplates the checking of the general state of opening mechanisms (hinges, counter-weights and cables, etc).
- Folding doors must be fitted with a retaining system in the open position to prevent sudden collapsing if any of the opening mechanism components were to fail.
- No loading or unloading operations should be carried out within the vertical projection of folding doors.
