# Trapping of shackle identification plate cable

## QSE alert

Associated non-conformity code: EV.0000001187

Incident in a wind farm during major corrective work to change the main shaft in Made 46 technology.

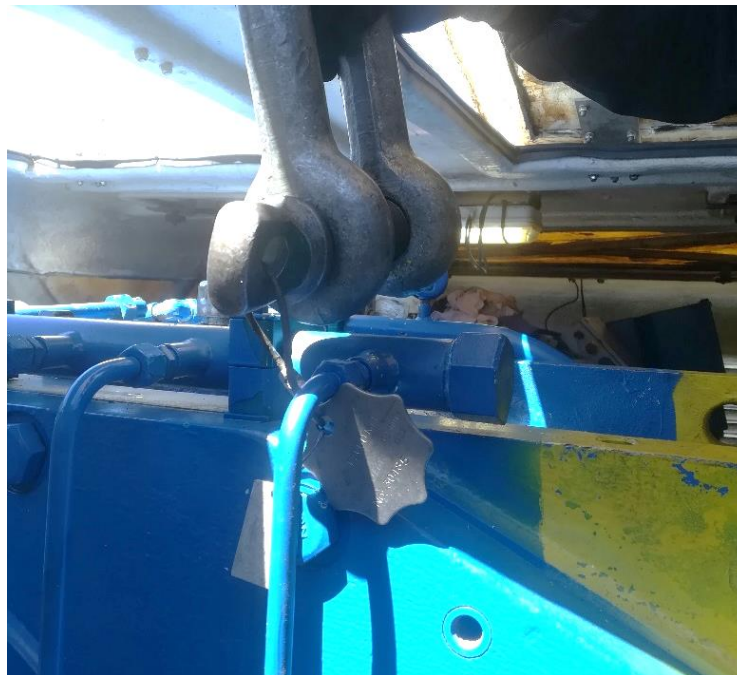
The crane driver was approaching with the lifting tools, a four-way bungee cord with four shackles for the technicians to fix on the gearbox lugs. During this operation a ring fitted to secure the identification plate on one of the shackles caught on the gearbox structure, specifically on a hose.

*Shackle identification plate caught on one of the gearbox hoses.*

When the crane collected the cable to position the tool correctly, this caused it to break the gearbox hose causing an uncontrolled movement of the tool, which could have hit the technicians in the nacelle.

- Eliminate the ring of twisted cable for the identification plate. This information must be engraved on the shackle itself. This measure must be applied to any element in a similar situation.
- Disseminate the contents of this alert to everyone involved in similar operations.

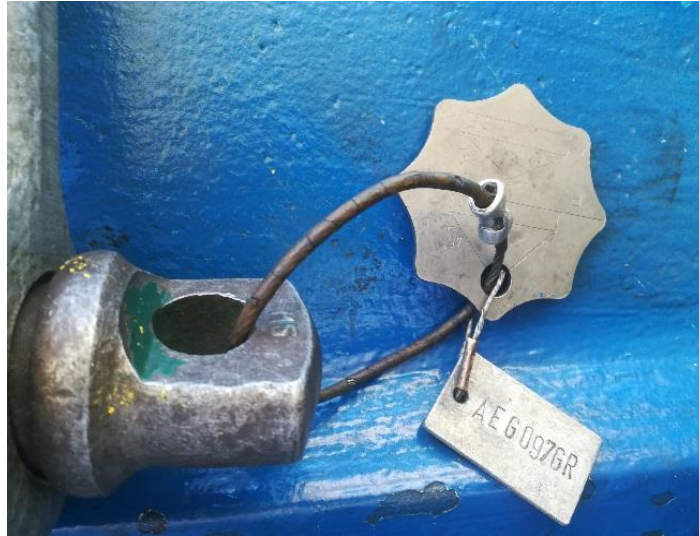
*Detail of ring securing identification plate to shackle.*

- Inadequate system for fixing the identification plate to the shackle.
- Before signs are given to the crane driver, the tools should be checked for proper placement with no elements that could interfere with the hook's movement.
- The technician giving indications to the crane driver must never lose sight of the load and concentration on the task.
- Remember that loads should be raised and lowered slowly.
