# ELECTRIC ARC IN TOP CABINET

## QSE alert

Associated non-conformity code: NC2016005203

Wind farm belonging to Acciona Energía, September 2016

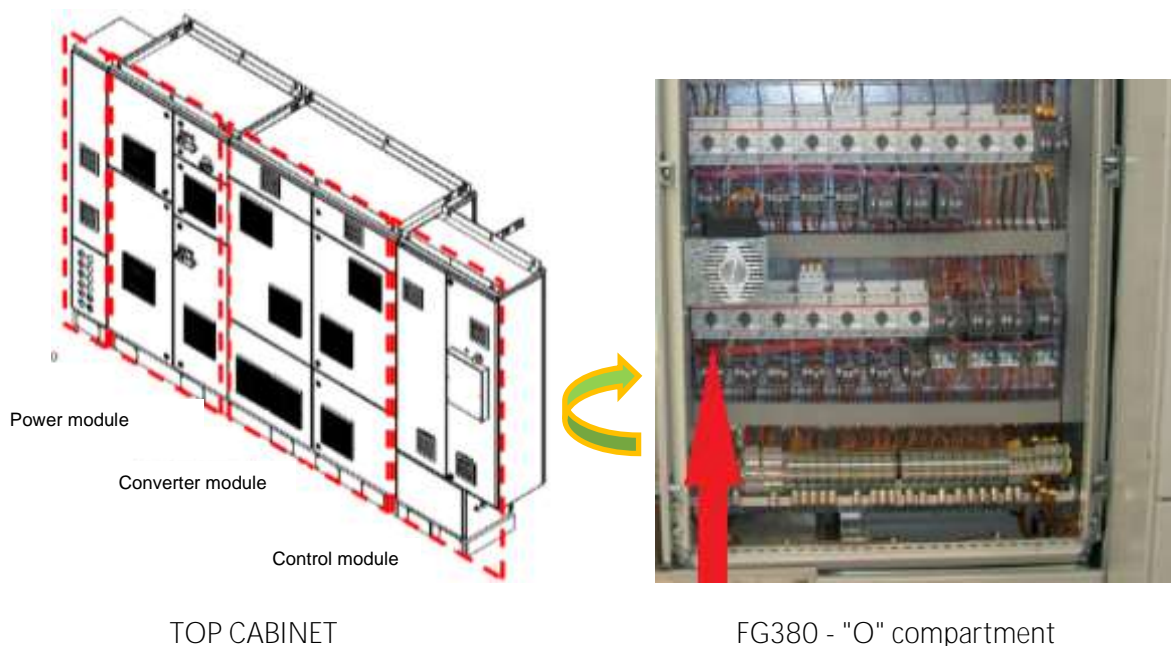
A maintenance technician was struck by an electric arc while working on the TOP cabinet of a G8X wind turbine. At the time of the accident, the employee was adjusting the FG380 motor protection breaker in the "O" compartment of the TOP control module, which is located at the rear of the cabinet (see the graphic details).

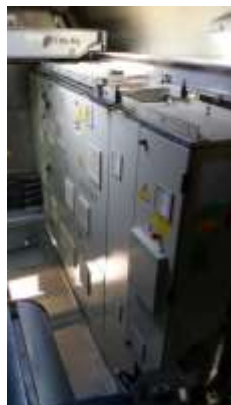
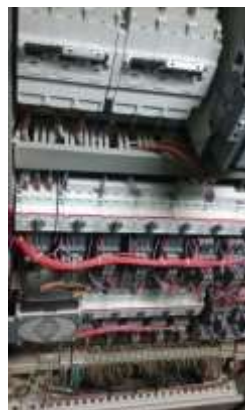
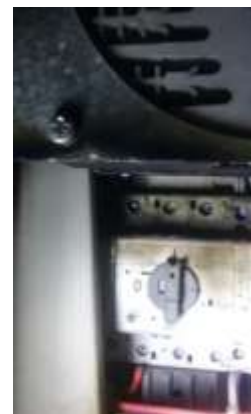
Before leaving the machine, the technician decided to retighten the motor protection breaker but, inexplicably, he did so with power applied and using a mechanic's screwdriver (non-insulated), which caused a short-circuit, together with an electric arc between the motor protection breaker terminal and the metal casing of the fan located just above the FG380,

Close-up of the TOP cabinet and motor protection breaker FG380, where the arc was produced.

- Any intervention involving electrical cabinet components, especially with tools, is considered electrical manipulation, and must therefore **be carried out with all power removed from the installation. WORKING WITH POWER APPLIED IS STRICTLY FORBIDDEN!**

- All operations, measurements, testing or checks that can be made with power applied require that prior protection measures be adopted: adequate PPE (**dielectric gloves** suitable for the service voltage, **visor and clothing providing protection against electric arcs**), appropriate tools (insulated or insulator), together with measurement equipment of a suitable class.

- Before working in the "O" compartment of the TOP cabinet, isolation switches FG002 and FG004, which are located in the power section (compartment "D"), must be opened. The UPS installed in the GROUND cabinet means that it is possible for some parts to still have power applied even after opening the power breakers, so that, **before any manipulation, ensure that all power has been removed by checking with a suitable voltage tester.**

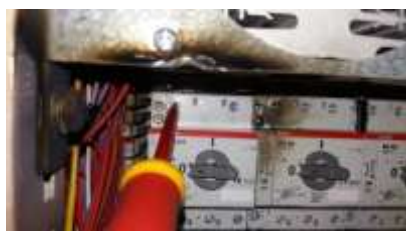
Area in which the short-circuit occurred. Simulated situation, WITHOUT POWER APPLIED and employing an insulated screwdriver.
