# UNINTERRUPTIBLE POWER SUPPLY SYSTEMS (UPS)

## QSE Alert

Non-Conformity Code associated: NC2016000318

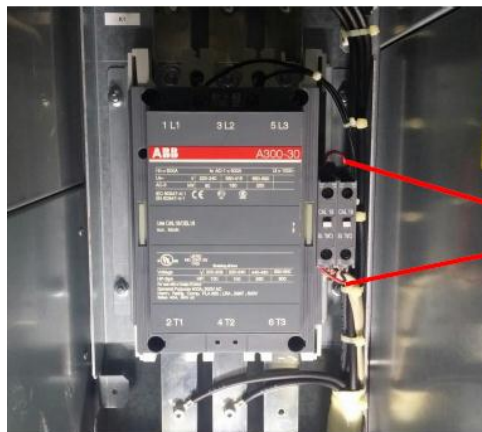
While repairing a fault in a wind turbine and even with the power supplies open and after checking for lack of power, a technician received an electric shock (230 V AC). At the time of the incident, the technician was working in the converter compartment without using personal protection equipment against electrical risks since he assumed that the installation was powered down.

Auxiliary contacts in which the electrical shock occurred.

After the shock (without consequences for the worker), the technicians carrying out the work realised that the power came from the UPS, which had not been disconnected. This shows that:

- All the power sources in the working area had not been identified properly.
- The check for the absence of power was not made correctly.

- Before carrying out any work, identify fully all the power supplies that affect the **working area** (including UPSs) and apply the **five golden rules** (power down, check for absence of power, etc). If the working area must be changed while working, apply the five golden rules again, starting with the complete identification of the power supplies that affect the working area and open or effectively cut them off.

- Respect the uninterruptible power supply systems (UPS):
  - Before working on any electrical installation, check for the existence of a UPS. Remember that the function of a UPS is to maintain power (generally 230 V AC) in certain auxiliary control circuits when the mains fails. These circuits may be powered even when the main circuit breakers in the wind turbine are open.

- To isolate a circuit powered by the UPS, switch off the UPS and **open its output circuit breakers** (power to loads).
  - Remember that the UPS will stop automatically in a mains failure and will re-start automatically when the mains returns. In each case, check the duration of the batteries.

- Before working on cabinets with a UPS, also check for absence of this power (generally 230 V AC).
