WWF Electric Line Clearance Management Plan

WWF ELECTRIC LINE CLEARANCE MANAGEMENT

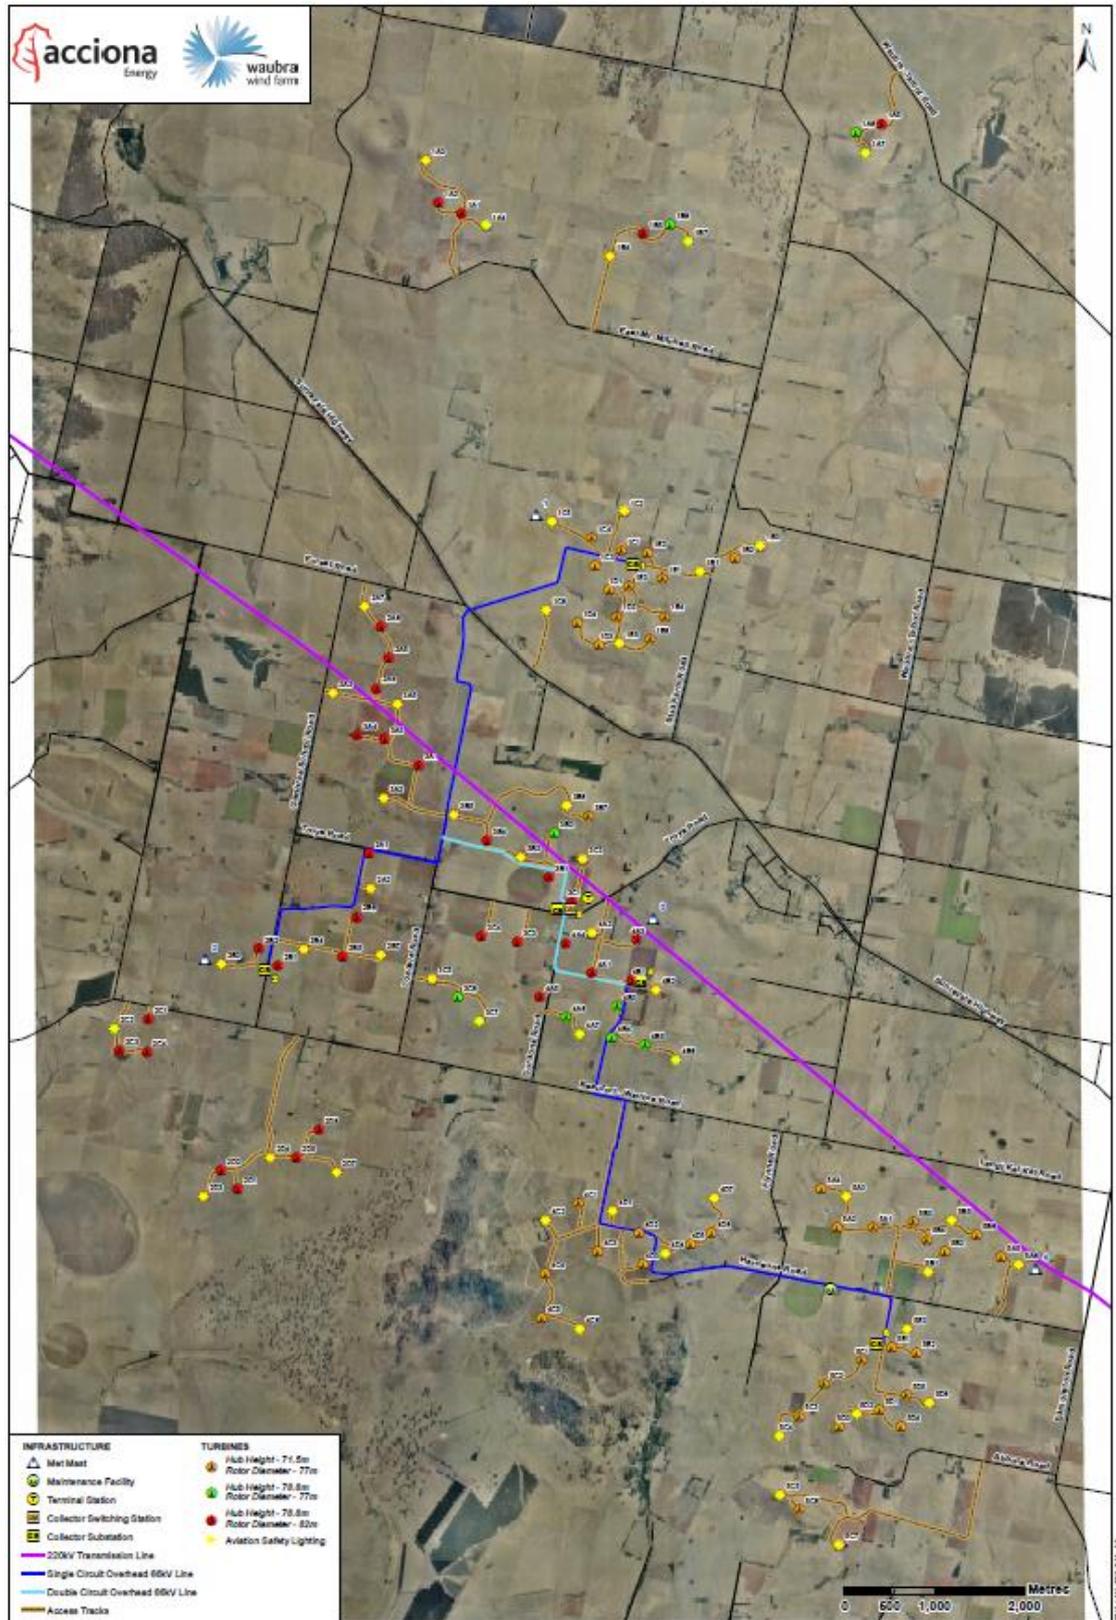
APPENDIX A | OVERVIEW MAP OF THE WAUBRA WIND FARM

An overview plan of the wind farm infrastructure, including the extent of overhead cabling, is illustrated in Appendix A.

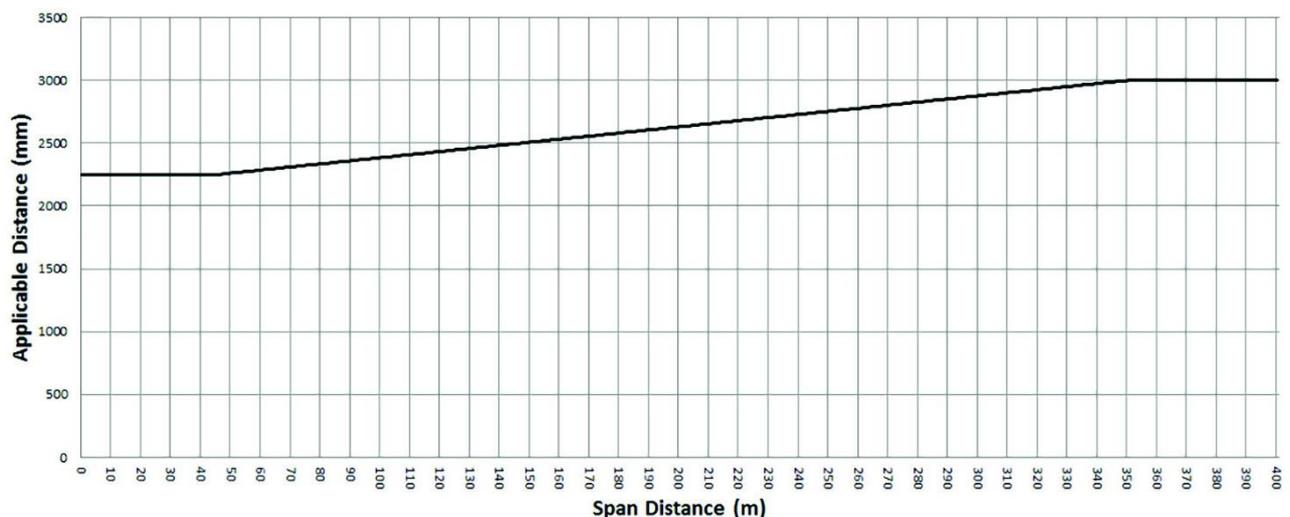
Graph 1
Uninsulated 66,000 Volt Electric Line on Hazardous Bushfire Area

The schedule to the Code specifies the minimum clearance space around electric lines that the Responsible Person must maintain. Waubra Wind Farm is located in a “hazardous bushfire risk area” and uses only uninsulated electric lines operated at 66 kV. Consequently, it is only ‘Graph 1, ‘Figure 1’ and ‘Figure 2’ which are relevant to this ELCMP. These tables and figures are reproduced below for convenience of the reader (reference should always be made directly to the Code in case changes have been made).

Graph 1 Formula

The formula by which the applicable distance for the middle two thirds of a span of an electric line to which clause 29 of the Code applies is calculated is as follows:

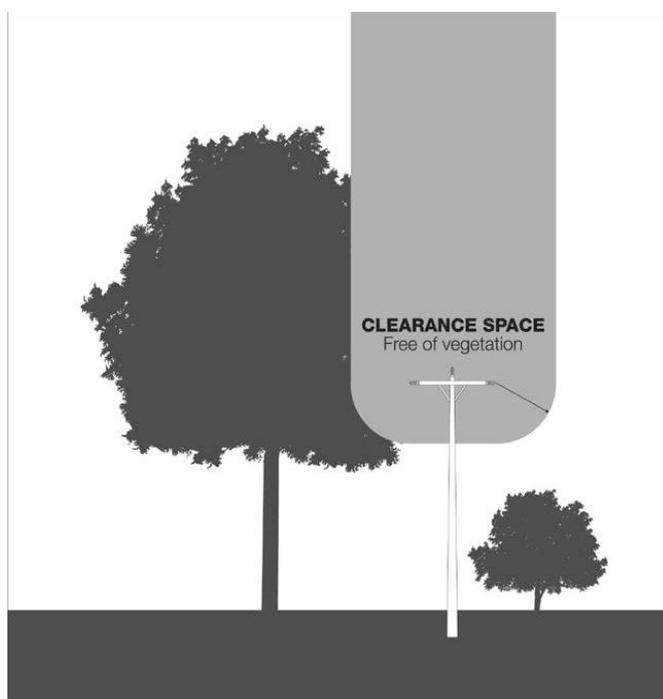
FIGURE 2:

Uninsulated 66 000 Volt Electric Line in a Low Bushfire Risk Area and Uninsulated Electric Line in A Hazardous Bushfire Risk Area
